# Aviation Investigation Preliminary Report

| <b>Location:</b> | Louisville, KY | <b>Accident Number:</b> | DCA26MA024 |
| <b>Date &amp; Time:</b> | November 4, 2025, 17:14 Local | <b>Registration:</b> | N259UP |
| <b>Aircraft:</b> | McDonnell Douglas MD-11F | <b>Injuries:</b> | 14 Fatal, 2 Serious, 21 Minor |

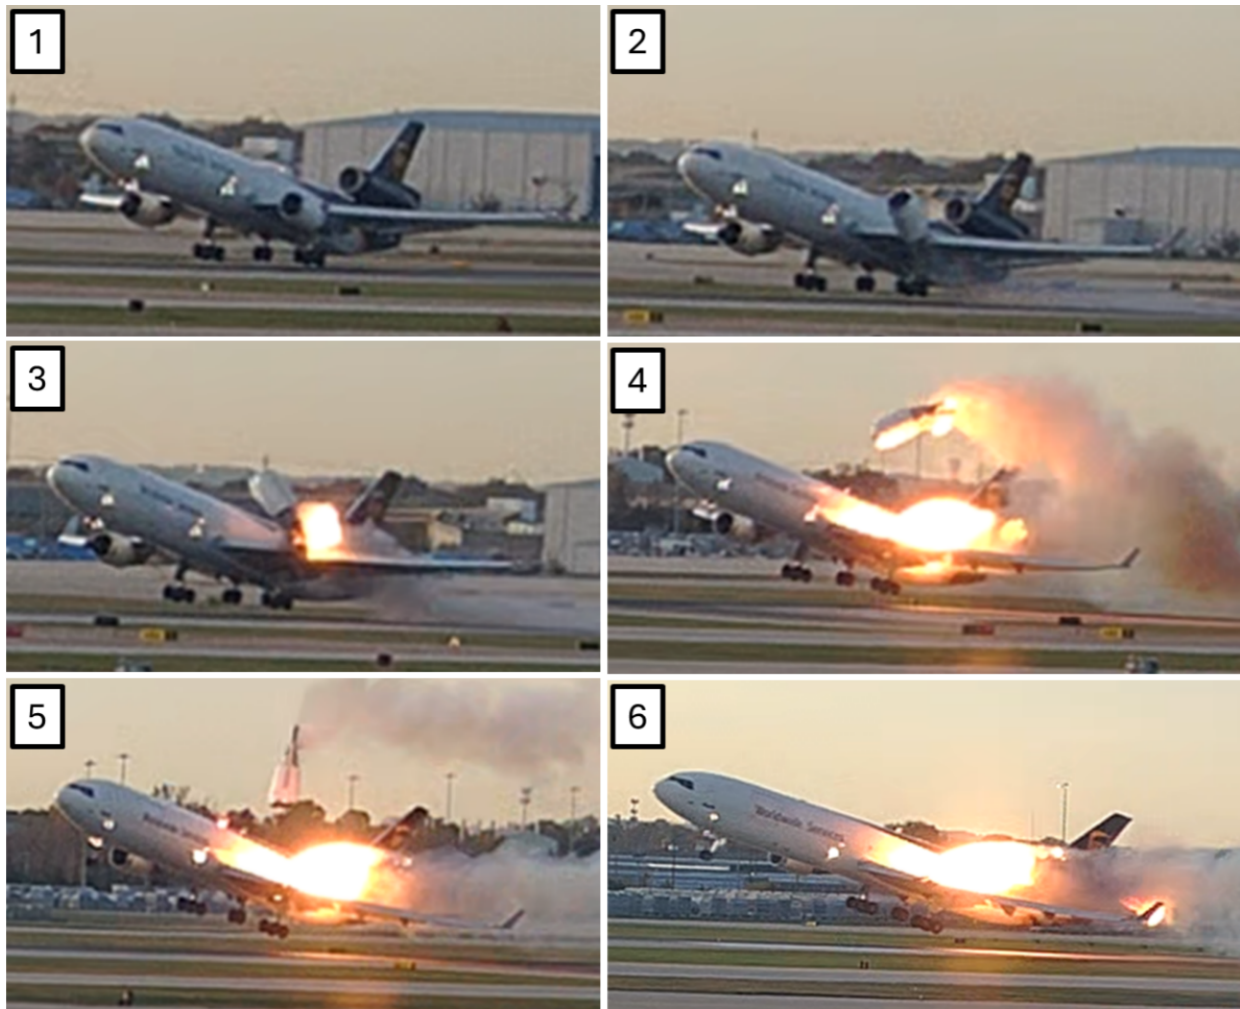
airplane rotated for takeoff. Airport surveillance video of the airplane showed the left (No. 1) engine and pylon separating from the wing shortly after airplane rotation, with a fire igniting on the left engine while it traversed above the fuselage and subsequently impacted the ground (see figure 1). A fire ignited near the area of the left pylon attachment to the wing, which continued until ground impact.

**Figure 1.** Still images from an airport surveillance video showing the left engine and left pylon separation from the left wing. (Source: UPS)

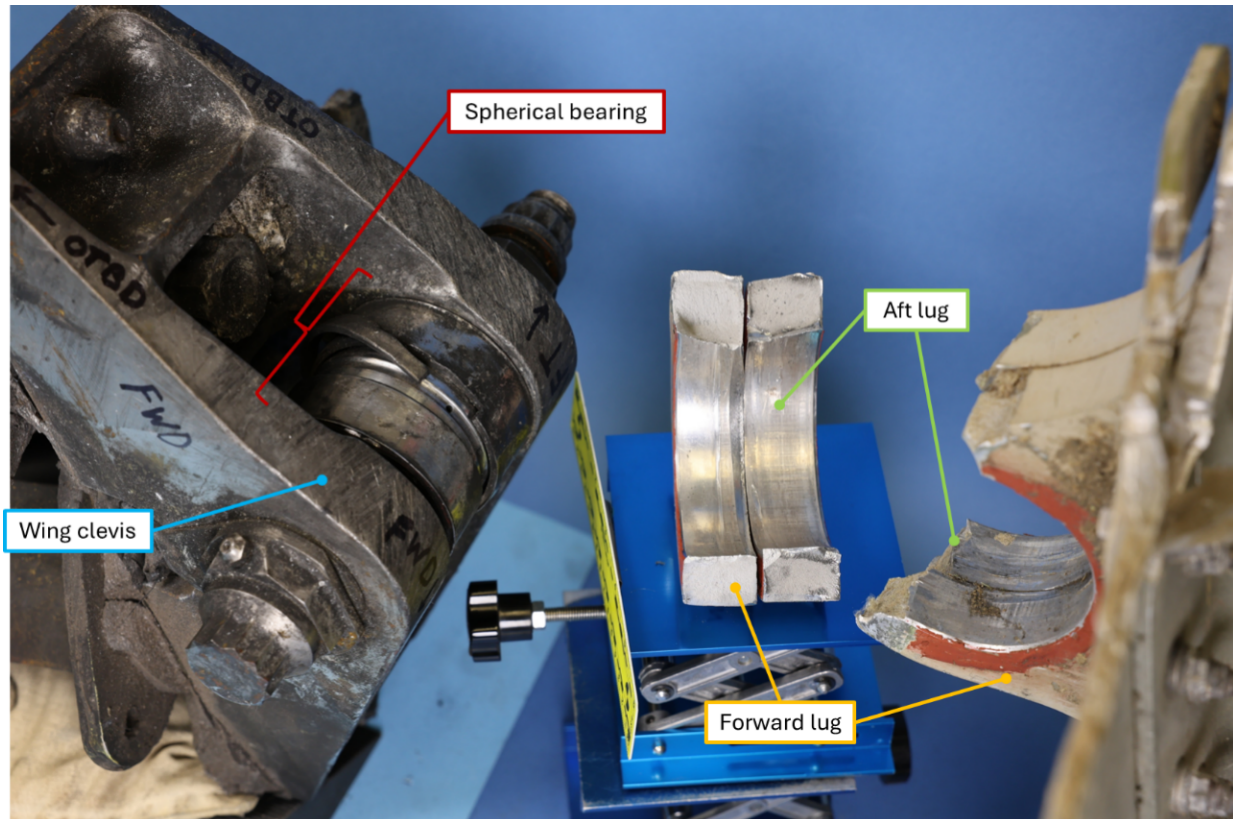
The left pylon aft mount, fractured lugs from the left pylon aft mount, and the left wing clevis (containing the aft mount spherical bearing and attachment hardware) were retained for further examination at the NTSB Materials Laboratory (see figure 9). The right pylon aft mount and wing clevis assembly as well as two engine fan blade fragments found on runway 17R were also retained for further examination at the NTSB Materials Laboratory.

**Figure 9.** The left pylon aft mount, the fractured and separated forward and aft lugs, and the left wing clevis containing the attachment hardware and fractured spherical bearing.

After initial cleaning of the fracture surfaces, examination of the left pylon aft mount lug fractures found evidence of fatigue cracks in addition to areas of overstress failure. On the aft lug, on both the inboard and outboard fracture surfaces, a fatigue crack was observed where the aft lug bore met the aft lug forward face. For the forward lug's inboard fracture surface, fatigue cracks were observed along the lug bore. For the forward lug's outboard fracture surface, the fracture consisted entirely of overstress with no indications of fatigue cracking. The forward top flange of the aft mount assembly was examined for indications of deformation or pre-existing fractures, but no indications were found. The spherical bearing was removed from the wing clevis for further evaluation (see figure 10).
